Stained Glass Restoration

The Sanborn House Historical & Cultural Center
Winchester Historical Society
with funding from the Arthur Griffin Foundation
Winchester Massachusetts

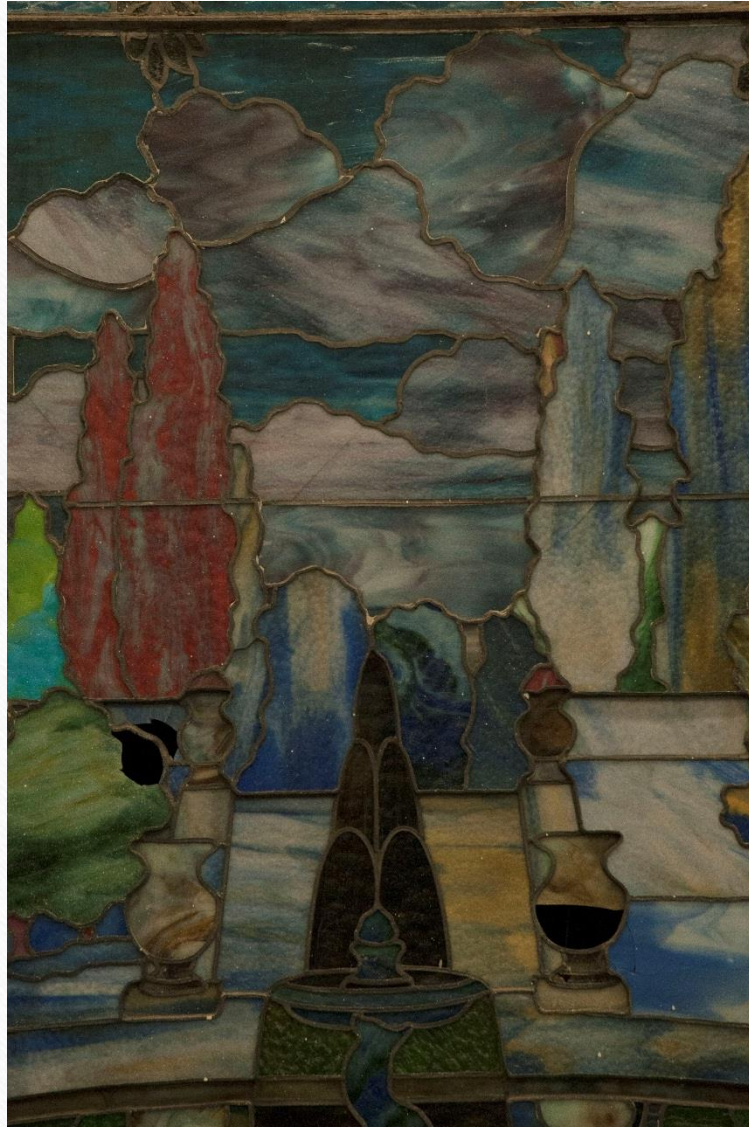
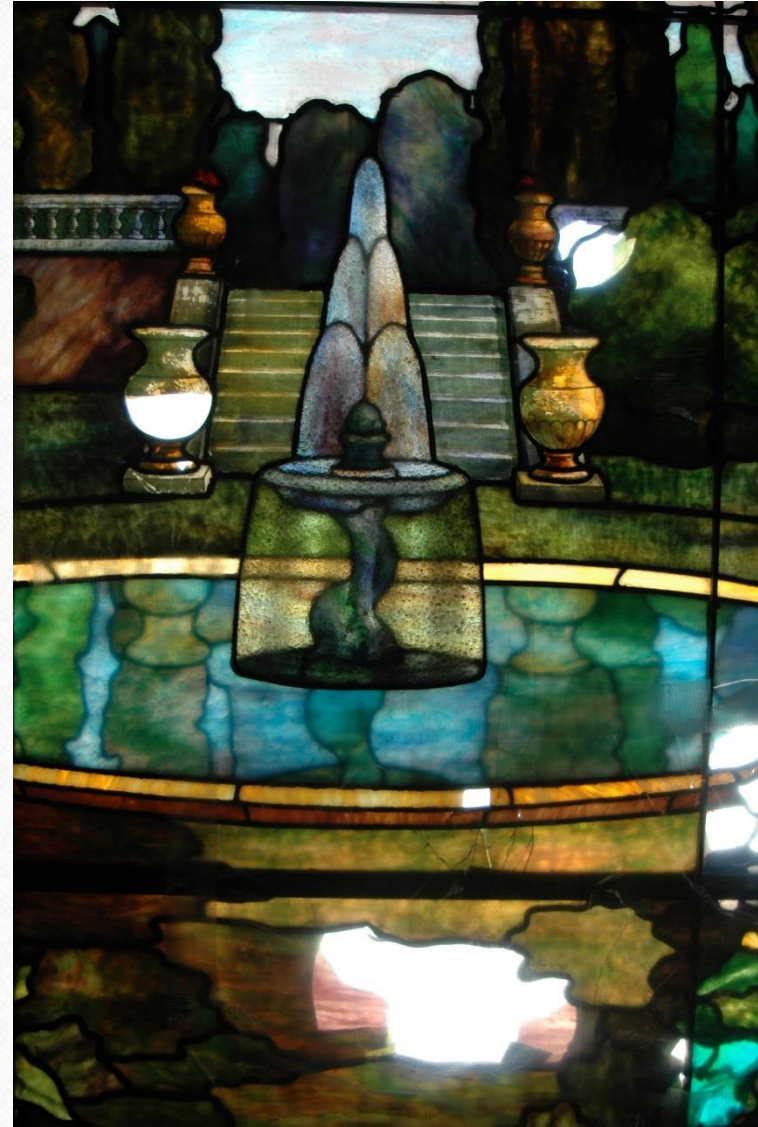
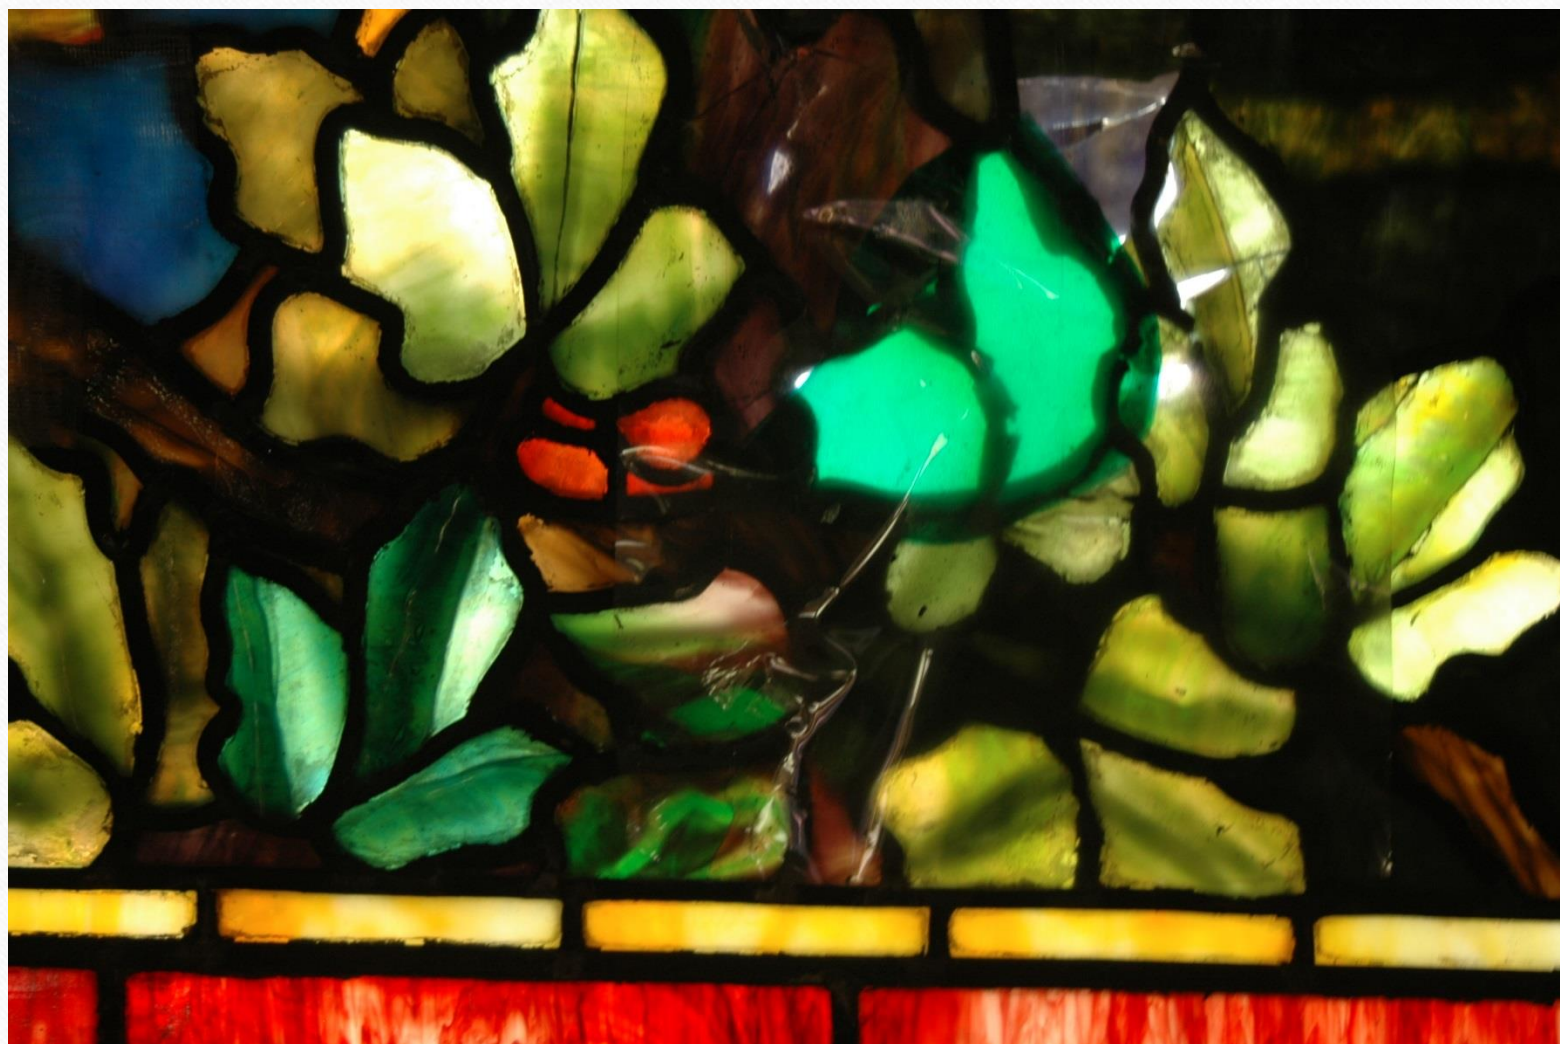
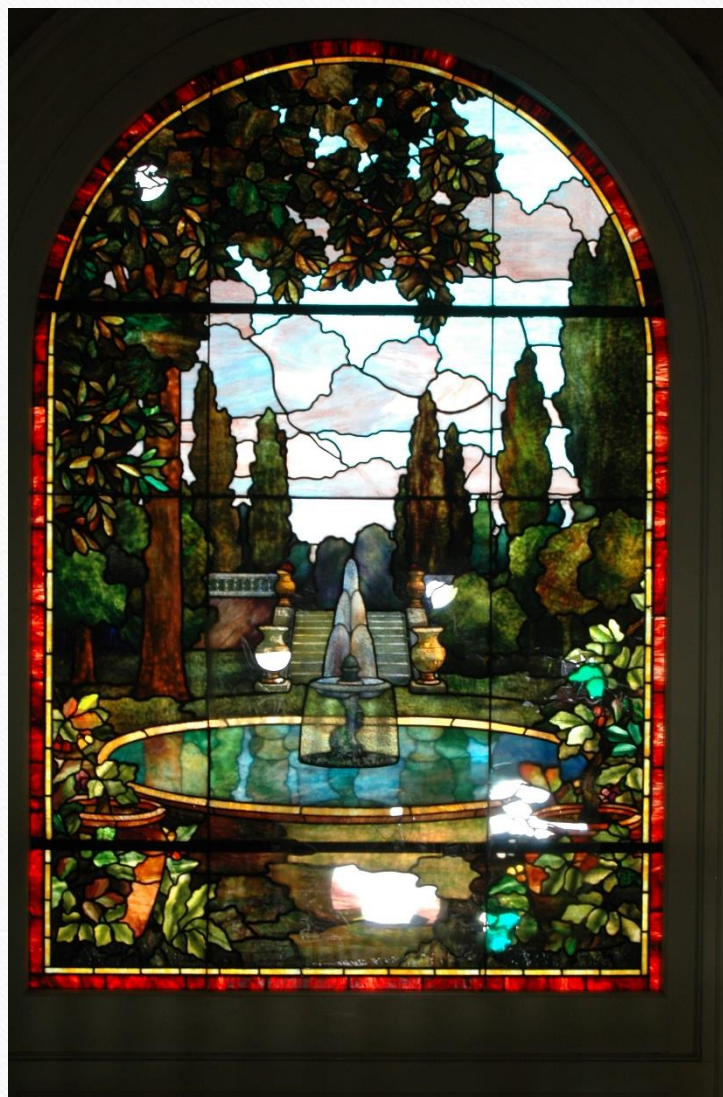
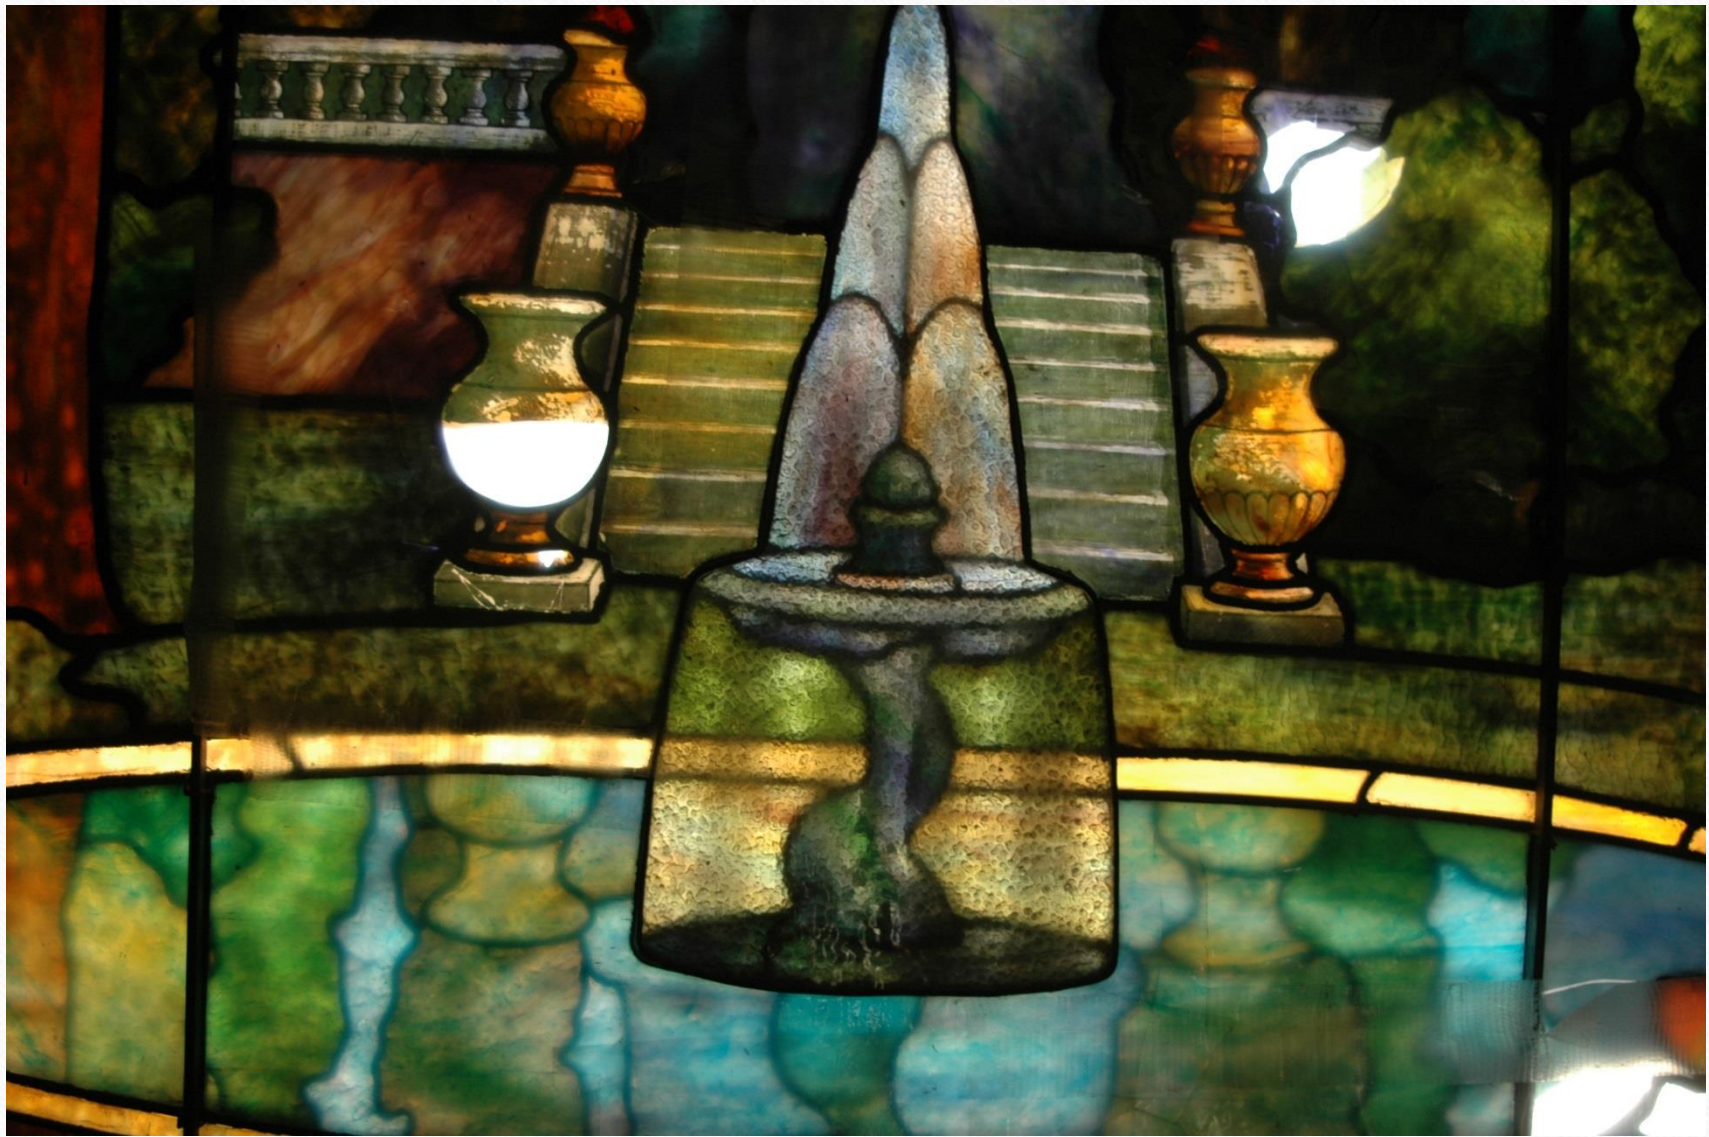
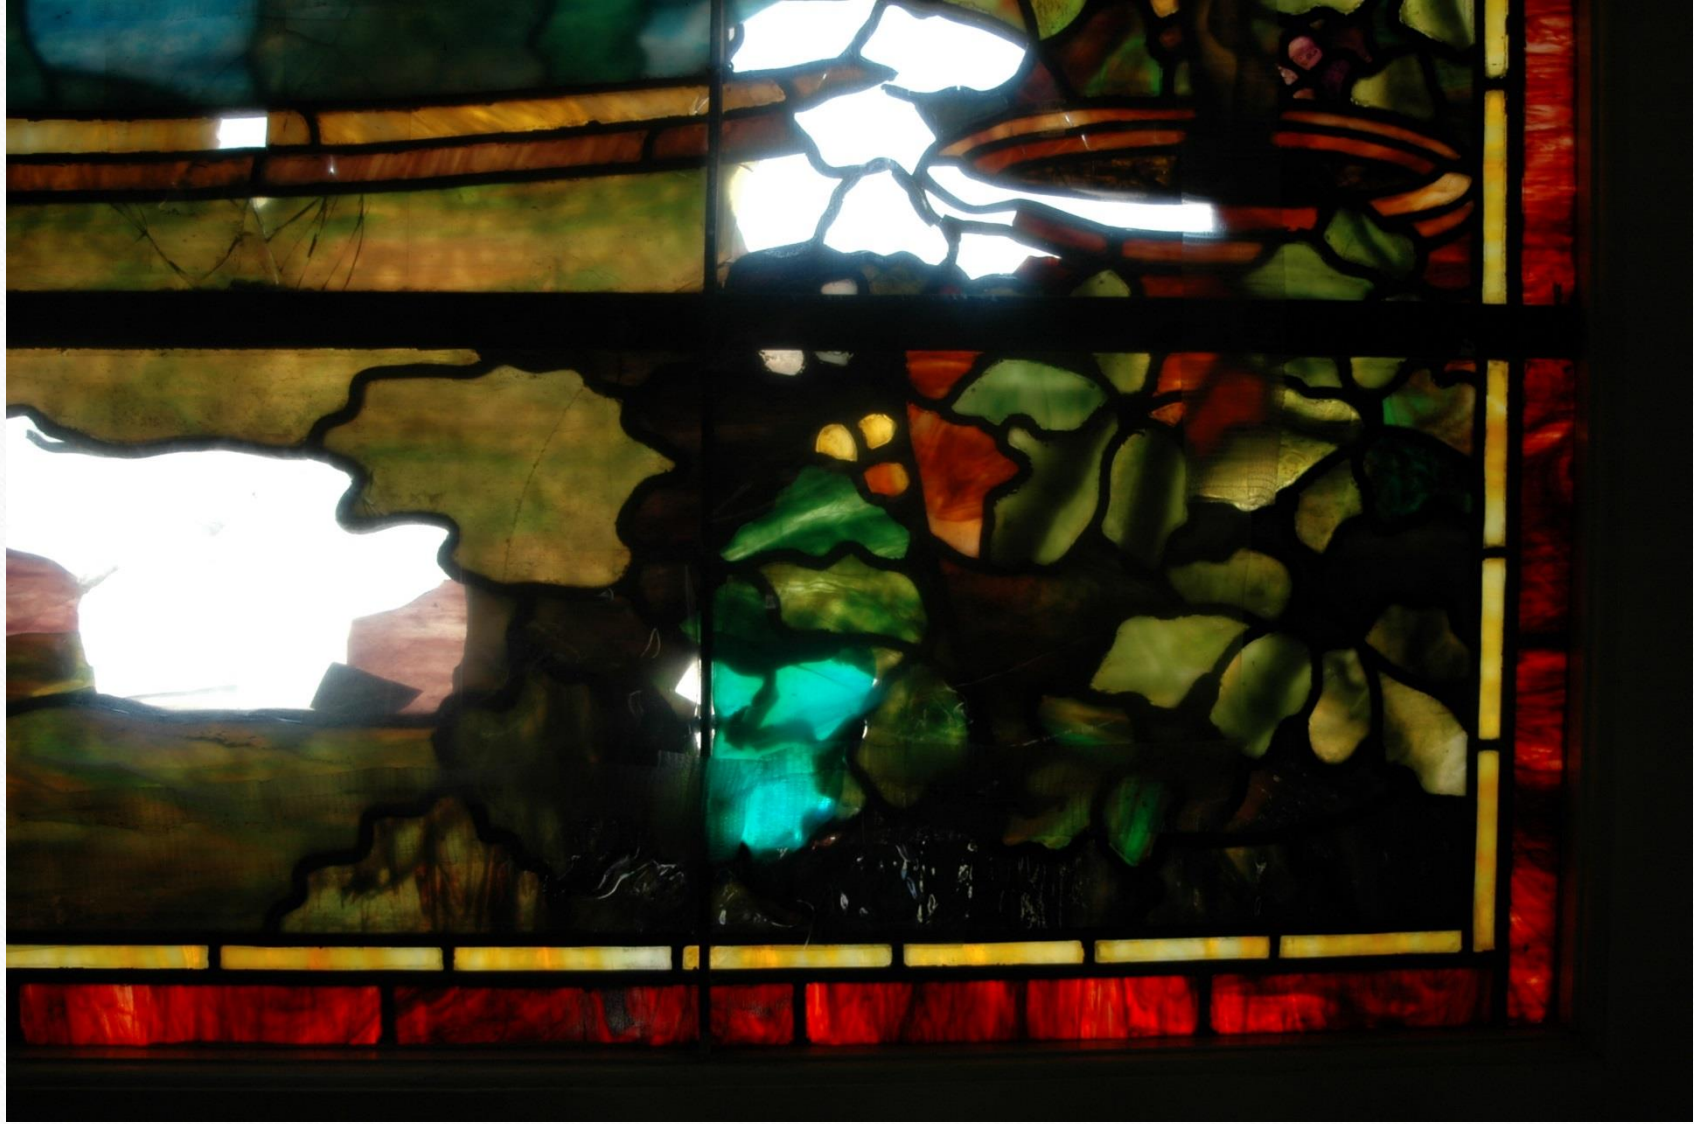
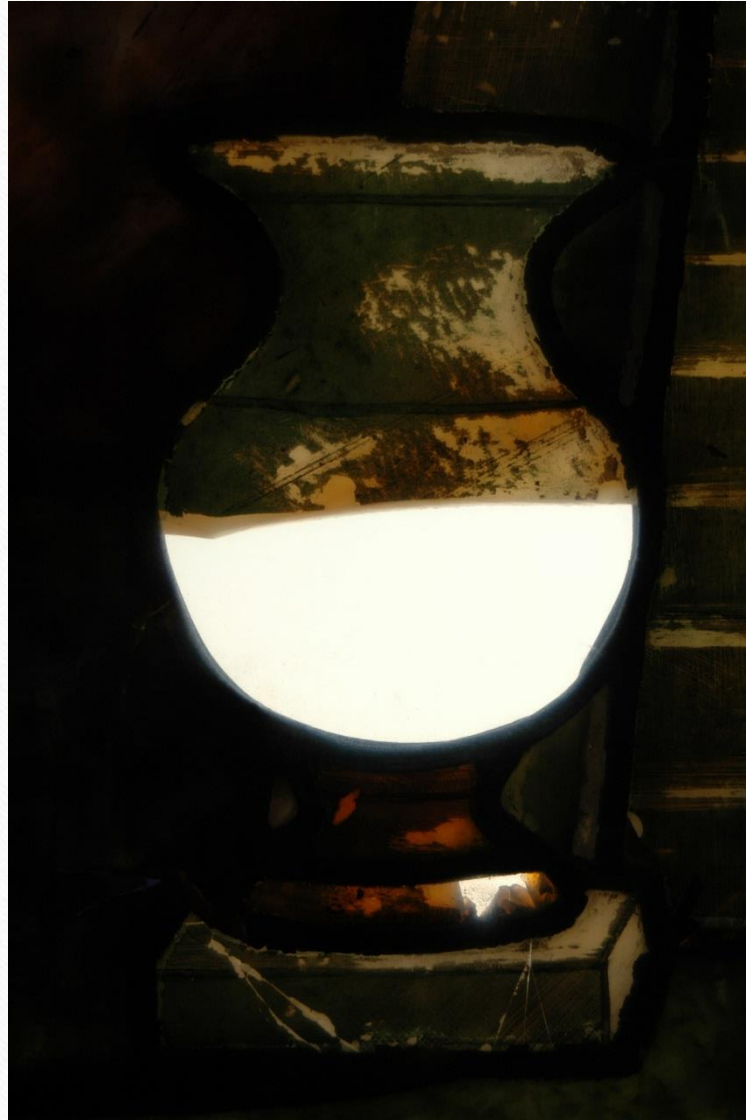
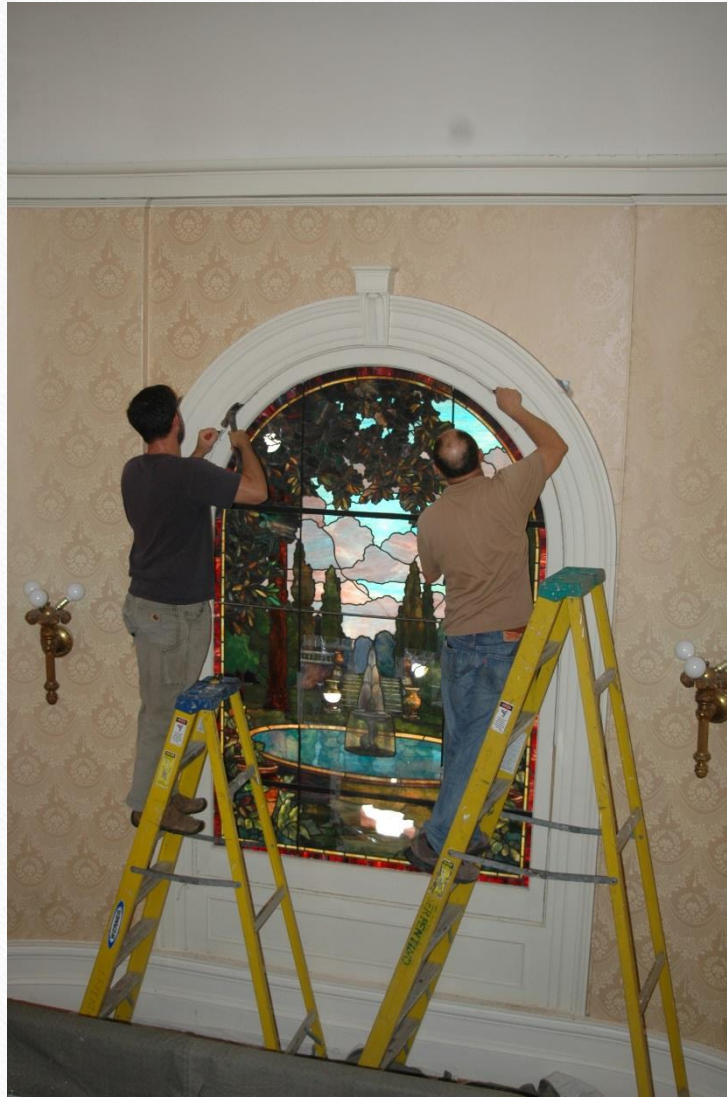
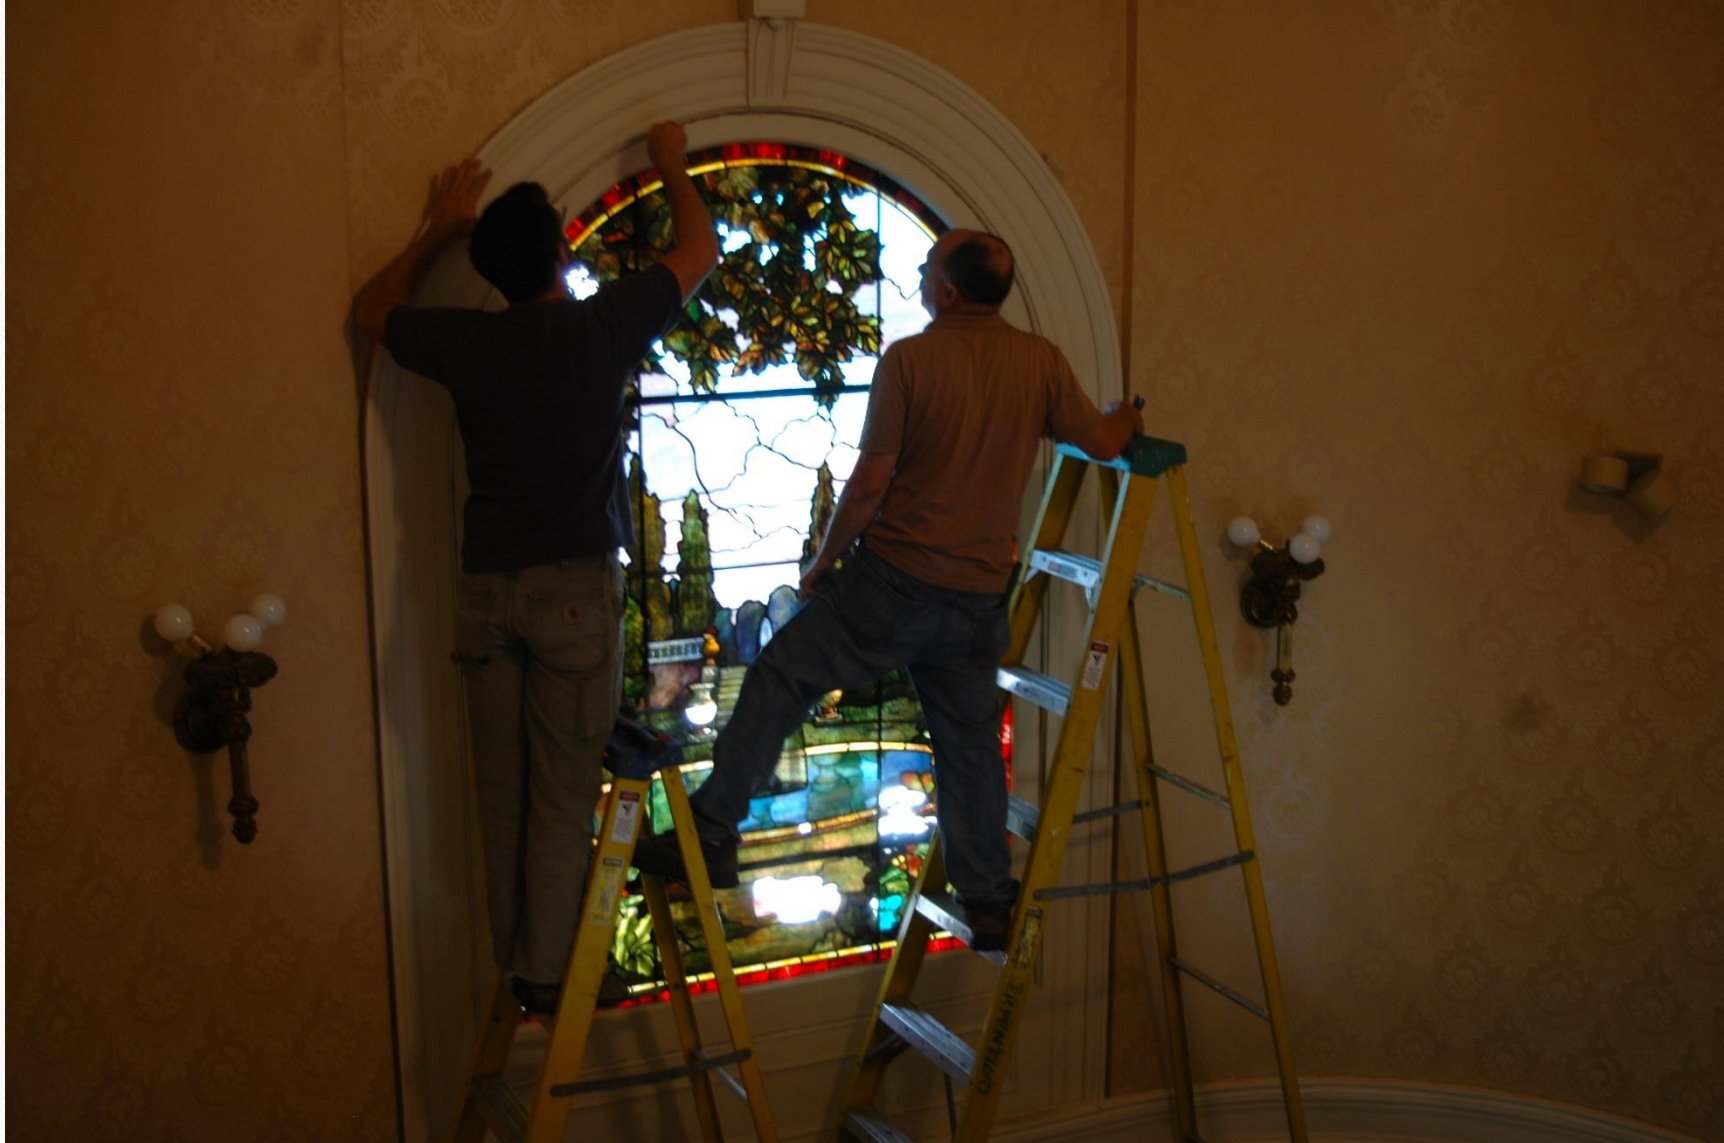
Before

The window, located in the Sanborn house, was dirty and broken. The artist of the window is unknown, however techniques invented by John La Farge in 1878, such as multiple plates and opalescent glass are used. The window was in rough shape.

Deflection was present, meaning that leaded window was bending away from the original flat design plane. There was cracked and broken glasses, some of the missing segments filled in with tape. The entire window was incredibly dirty and the dirt had infiltrated between the layers of plating in the piece. Metal fatigue was also present due to constant the flexing of the metal over time. The plan was to remove the window from the Sanborn house, transport it to Serpentino Stained and Leaded Glass studio and repair it before reinstalling it at the Sanborn house.
